Installation and Maintenance of Grease Interceptors

Application Formalities for
License for Food and Beverage Establishments

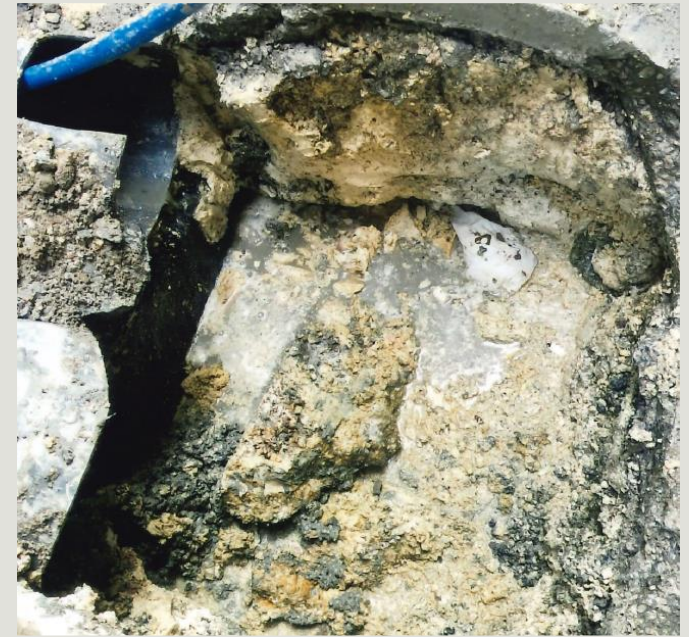
Blockage of public sewers due to improper cleaning of grease interceptors (*Rua do Rebanho*)

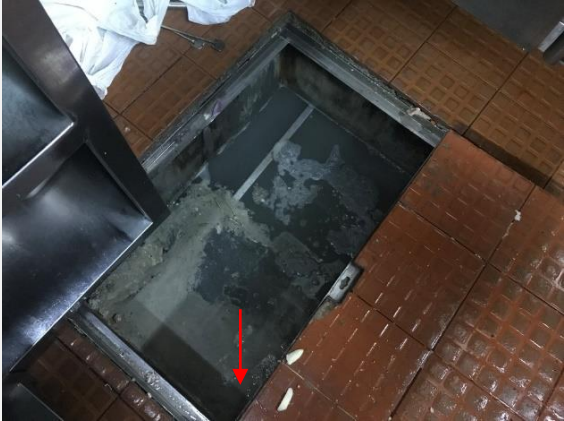
<p>Water level reaches the top.</p>	<ul style="list-style-type: none"> ●No grease separation function ●Direct discharge of grease into sewers ●Possible blockage of sewers 	<p>Issue written record immediately</p> <p>↓</p> <p>Clean up and make improvement as soon as possible</p> <p>↓</p> <p>Arrange re-inspection</p>

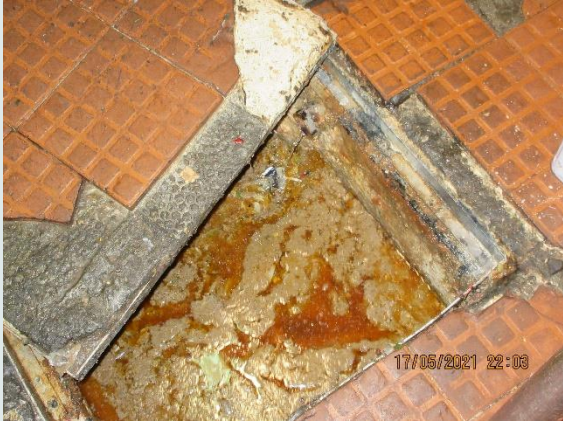
<p>Outlet compartment is filled with grease and water level reaches the top.</p>

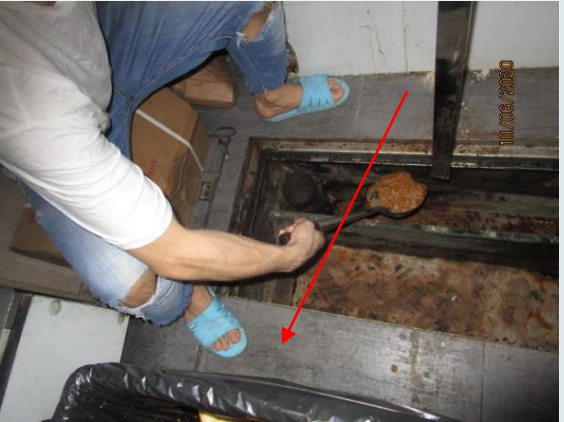
<p>Grease has hardened.</p>

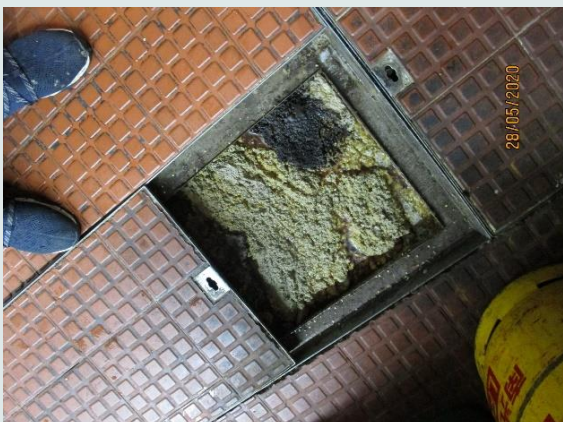
<p>Grease reaches the top.</p>

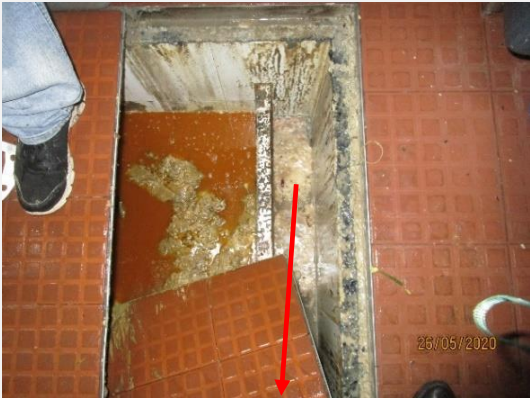
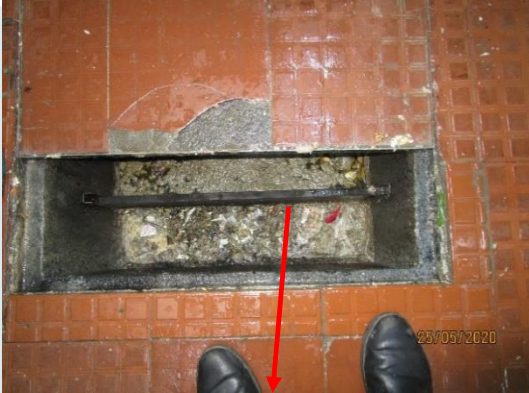
The grease interceptor lacks cleaning and grease has been discharged to sewers.	<p>Issue written record immediately</p> <p>↓</p> <p>Clean-up and make improvement as soon as possible</p> <p>↓</p> <p>Arrange re-inspection</p>
Grease flowing from water outlet	Grease flowing from water outlet

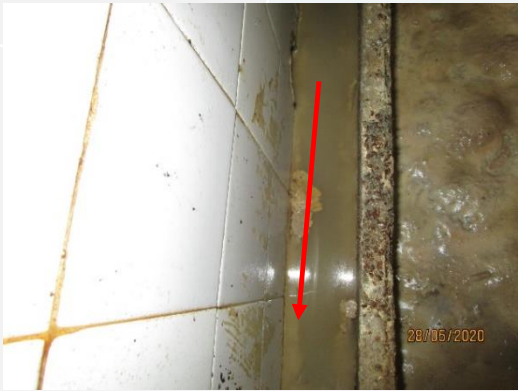
Poor clean-up	<p>Issue notice</p> <p>↓</p> <p>Strengthen clean-up</p>
A small amount of grease at water outlet

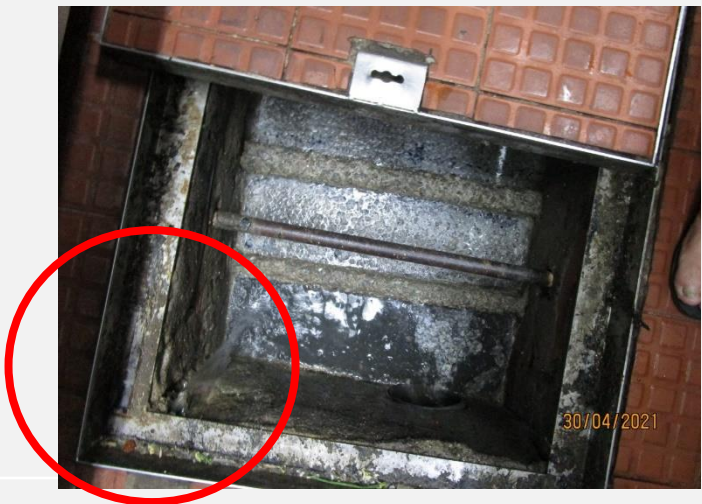
<p>A photograph showing the interior of a grease interceptor. A red circle highlights the outlet compartment, which is the lower section where grease and sewage are discharged. The date stamp '30/04/2021' is visible in the bottom right corner.</p>	<ul style="list-style-type: none">● Unauthorised addition of sink, and grease and sewage are discharged into the outlet compartment of grease interceptor● Grease and sewage of sinks are required to be discharged to the inlet compartment through pipes.	<p>Issue written record immediately</p> <p>↓</p> <p>Make improvement within deadline</p> <p>↓</p> <p>Arrange re-inspection</p>

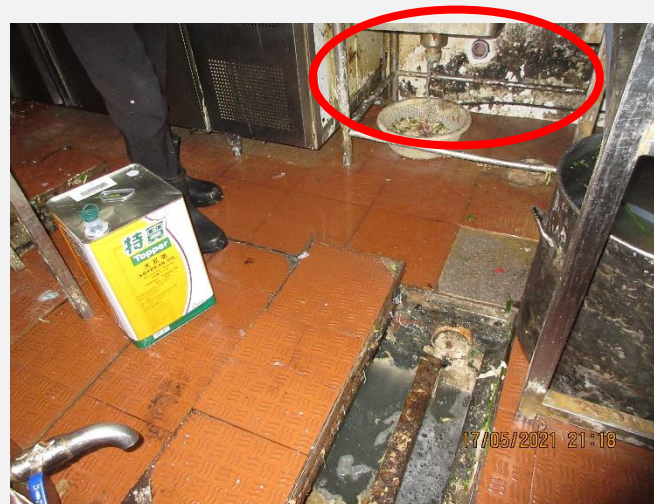
<p>A photograph of a kitchen floor with orange tiles. A red circle highlights a drainage pipe opening where a sink has been removed. A yellow container is visible on the floor. The date stamp '17/05/2021 21:18' is visible in the bottom right corner.</p>	<ul style="list-style-type: none">● Illegal removal of drainage pipes● Grease and sewage are discharged to the outlet compartment of grease interceptor from the floor.	<p>Issue written record immediately</p> <p>↓</p> <p>Make improvement within deadline</p> <p>↓</p> <p>Arrange re-inspection</p>

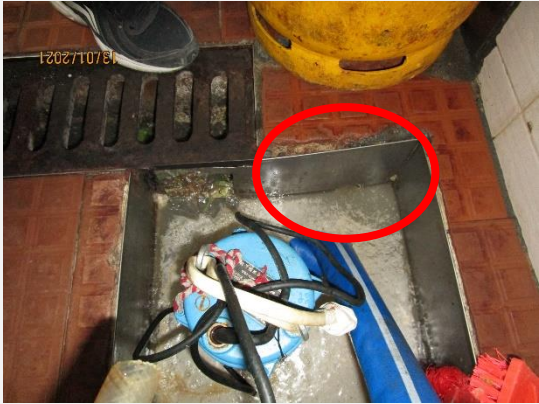
<p>Illegal alteration – illegal water outlet of pump sump</p>	  <p>Illegal water outlet has been sealed.</p>

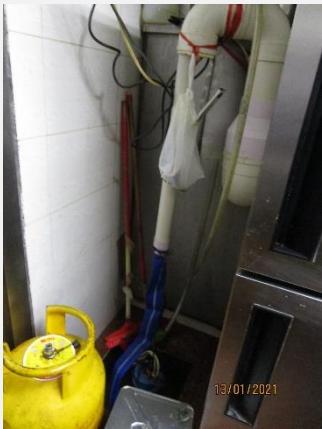
<p>Changed to temporary soft pipe that does not meet the specifications</p>
